## Multiple Mitigation Measures Ease Town's Trouble

### Full Mitigation Best Practice Story

#### *Waldo County, Maine*

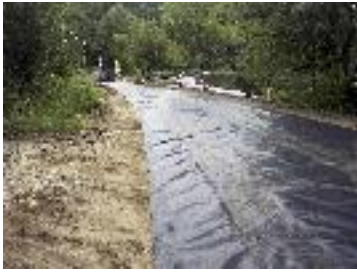
Geotextile

The solution to the problem involved multiple mitigation measures. First, 900 feet of the old road surface was removed. The roadbed was then lined with geotextiles, a permeable fabric engineered to control drainage and to keep the water table from rising above the road. When used in association with stone and soil, geotextiles have the ability to separate, filter, reinforce, protect, or drain water from an area. The ditches on either side of the road were also lined with geotextiles and stone.
